PORTLAND'S UNREINFORCED MASONRY APARTMENT BUILDINGS: A THREATENED SPECIES?

WALTER W. McMONIES

Roberts Kaplan LLP

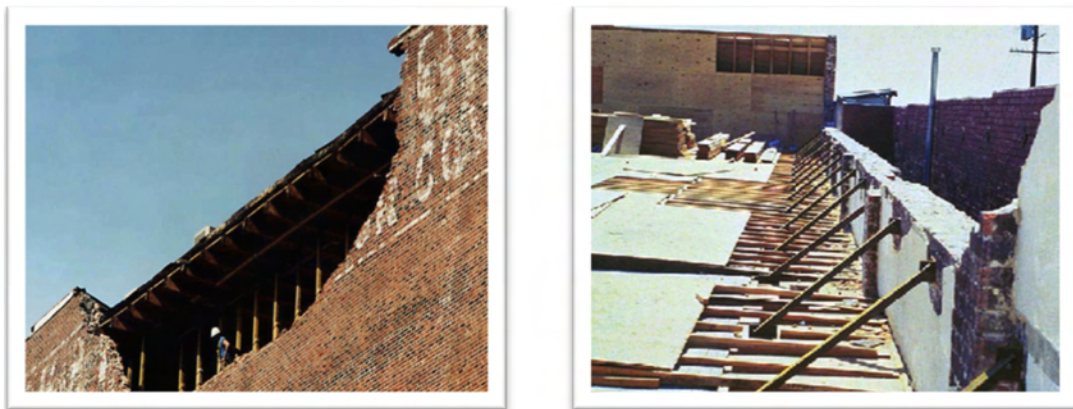
Figure 6.1 Example of parapet failure (l) and parapet bracing (r)

1. Injury to Persons. Bricks are heavy and when they fall can injure or kill people. Parapet walls, chimneys and cornices are all vulnerable to falling off and hitting people. URM buildings can partially or entirely collapse in a major earthquake, trapping, injuring and even killing occupants.
2. Damage to Property. Because URM buildings typically lack any integrating reinforcement or any tying together of structural elements, a major earthquake can potentially

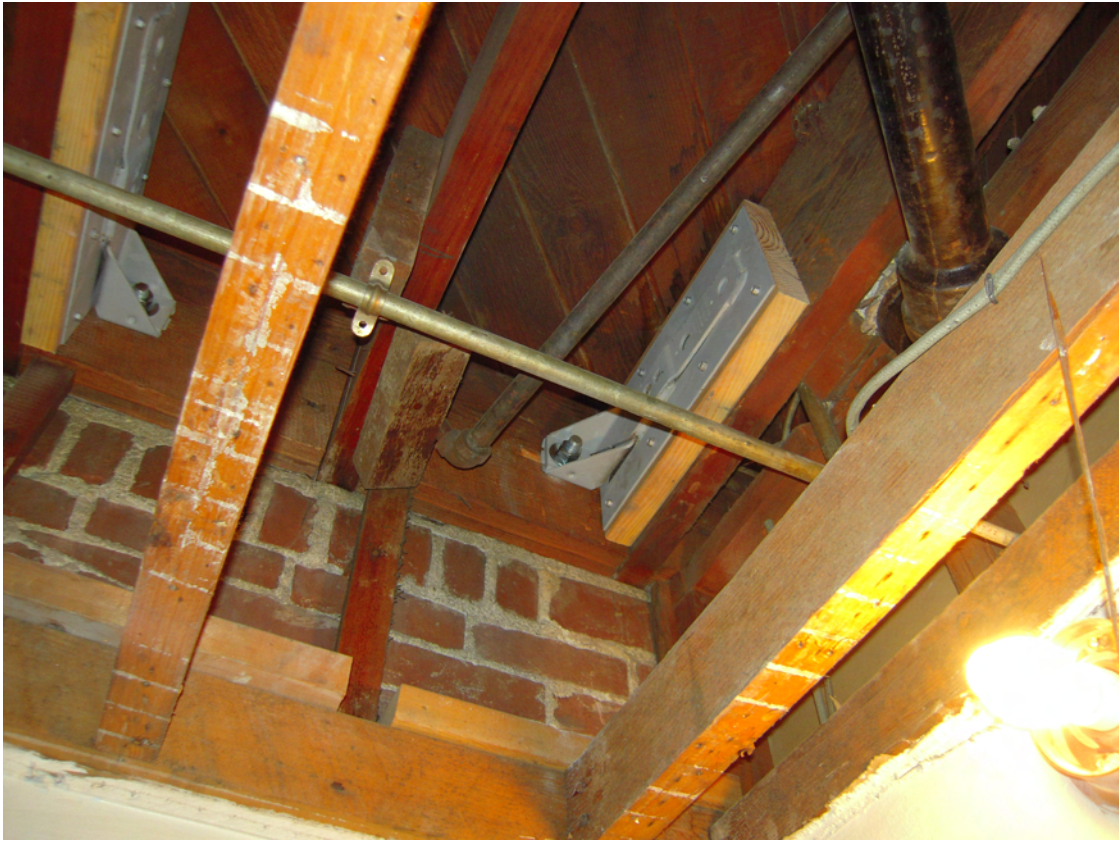
Figure 6.3 Example of a floor joint tie back in Trinity Place Apartments
